5 Engineering Criteria

5.1 Structural Integrity

5.1.1 Tappan Zee Bridge Rehabilitation Options

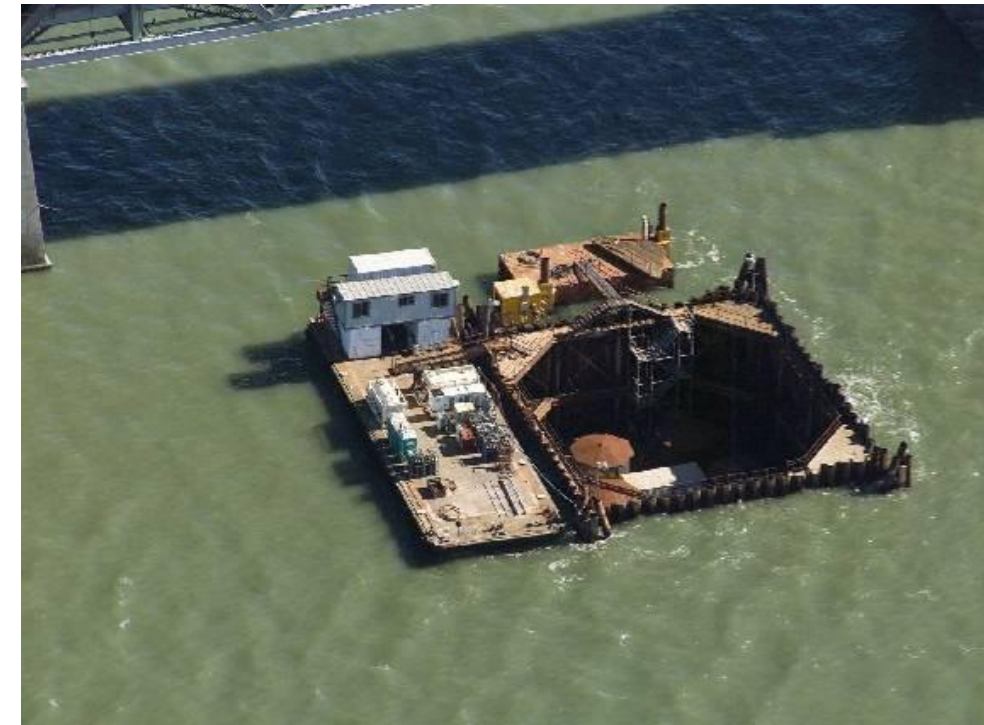
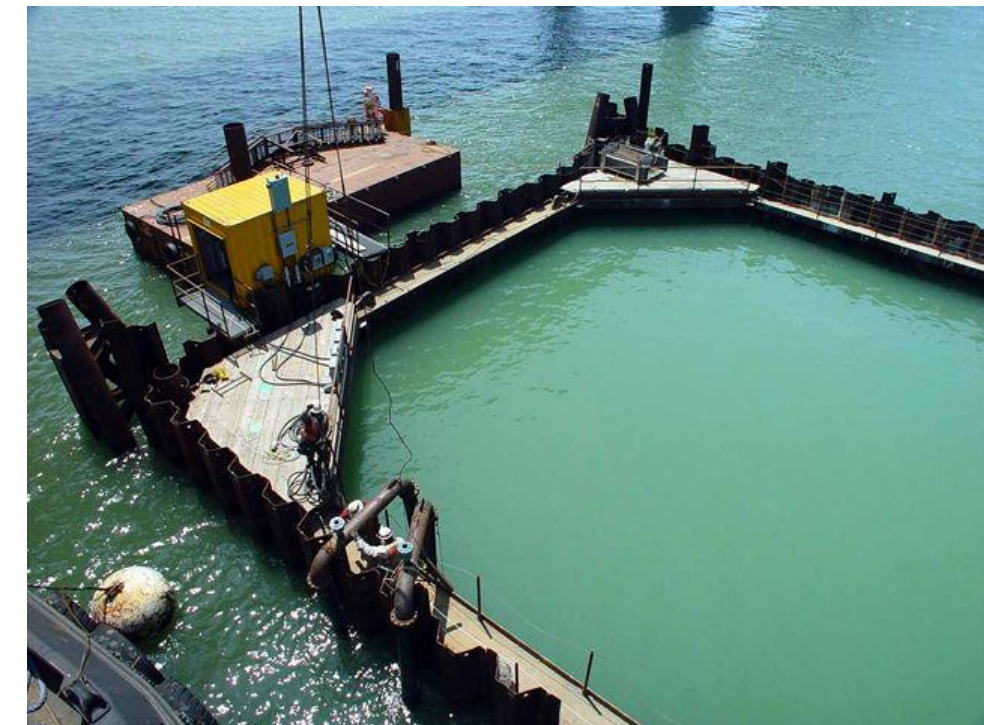
Figure 5-5
Cofferdams (Caltrans 2004)

- In the Rehabilitation Options, two cofferdams will be required adjacent to each of the eight Buoyant Foundations for construction of the replacement foundations. To allow the new foundations to be as close as possible to the existing piers, the existing ship protection will need to be demolished and the supporting piles removed to avoid conflicts (Figure 5-6, Page 52). New temporary ship protection measures will be required to protect the Buoyant Foundations during construction. Typical construction sequences for foundation construction are shown in Figures 5-3 and 5-4 (pages 49 & 50).
